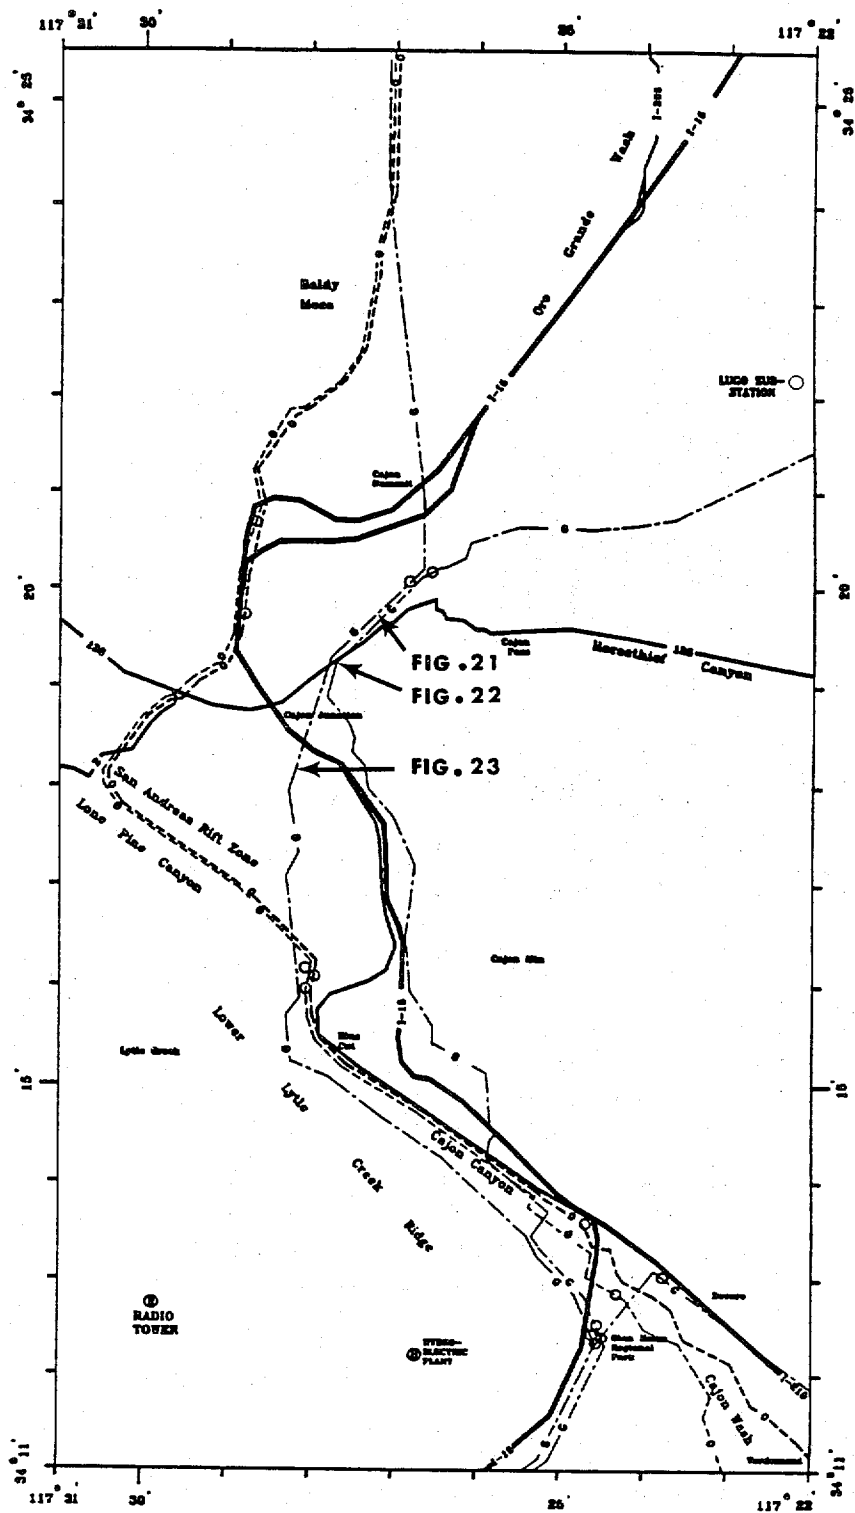
Figure 20, FUEL PIPELINE LIFELINE ROUTES

Figure 20 shows the fuel pipeline lifeline routes in the study area. The location of the photographs presented in this section of the report are also shown on the figure. The lifelines include one 8- and one 16-inch petroleum products pipelines, three 36- and one 16-inch natural gas pipelines, and the associated valves for each line. Modern
